4. TITLE (and Subtitle) Phase I Inspection Report National Dam Safety Program Edmondson Dam Washington County		5. TYPE OF REPORT & PERIOD COVERED Final

~~EDMONDSON DAM~~

WASHINGTON COUNTY, VIRGINIA,

PHASE I INSPECTION REPORT.
NATIONAL DAM SAFETY PROGRAM

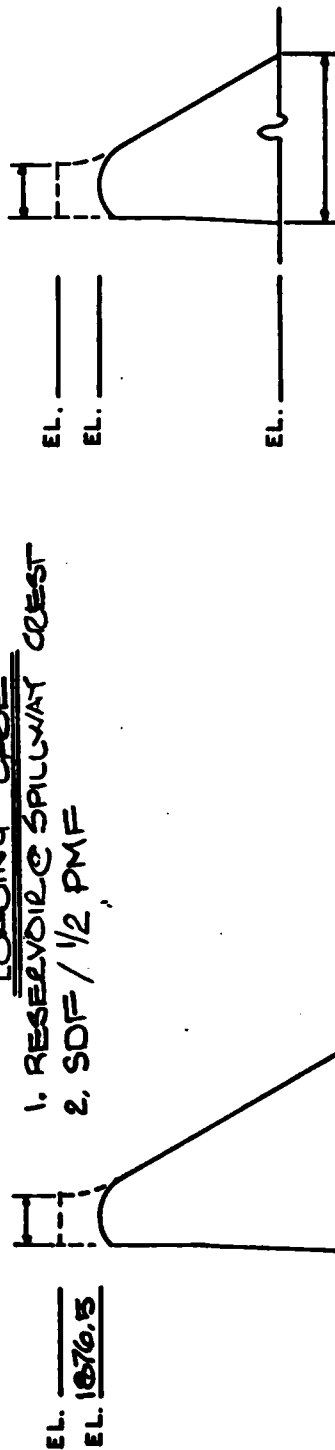
TABLE 6.1

LOADING CASE	ELEV. HEAD WATER	ELEV. TAIL WATER	ΣV	ΣH	$\frac{\Sigma H}{\Sigma V}$	LOCATION RESULTANT FROM TOE	% BASE IN COMPRESSION	FACTOR SAFETY SLIDING	FOUNDATION PRESSURE	
									TOE	HEEL
1	1876.5	1841.5	79.7 K	47.6 K	0.6	16.4 FT.	100%	2.6	39 PSI	22 PSI
2	1892.5	1865.0	49.9 K	64.3 K	1.3	2.5 FT.	12%	1.5	-	-
